The Timber and Construction of Dragon Hall

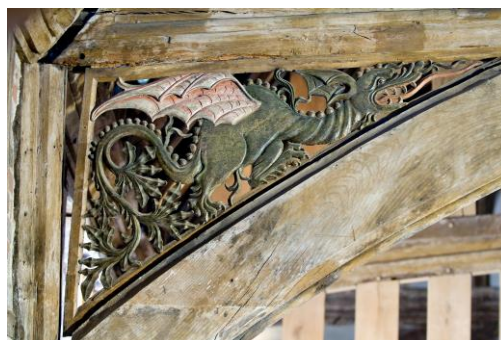
The third source of timber was slow-grown radial planks, imported from the Eastern Baltic. The remaining dragon in a spandrel in the Great Hall was carved on these fine boards.

Dragon carving in spandrel

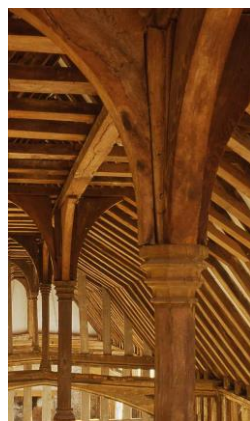
The floor joists and spine or central beams and their joints were prefabricated and assembled on the ground to check everything fitted before being reassembled in their final position. The roof timbers were made in sets and then a set was used randomly. In three of the ground floor rooms you can see the carpenters' marks as Roman numerals used to identify each joint when the building was erected. The roof is of a crown post type with four braces to the purlin and collar above. "Crown" refers to the shape of the moulding at the top of the post.

The crown post roof

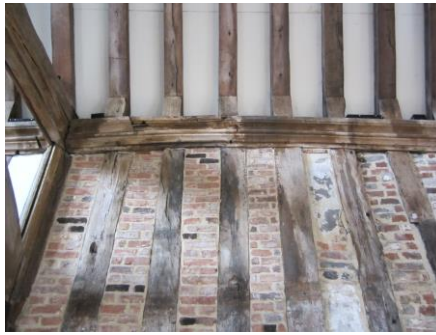
The wall posts or studs were placed much closer together than is structurally necessary and than in most medieval buildings, suggesting that Robert Toppes wanted to show off the cost of his trading hall. Likewise the decorative mouldings on the facing edges of the wall posts, of a type more commonly found in wealthy domestic buildings, were designed to impress his customers. In addition, brick infilling between the studs was used rather than the cheaper wattle and daub, although it is possible that the bricks were inserted later when the hall was converted into living spaces.

Studs with brick infill

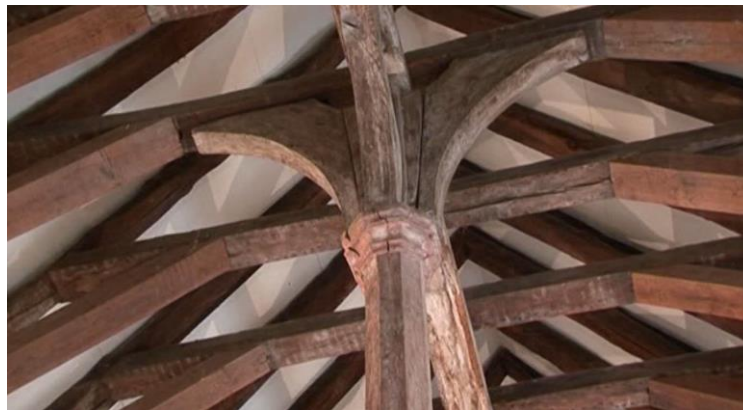
The joints for the cross or tie beams, crown posts and arch braces are mortice and tenon with oak pegs to hold them together. One could say that with no use of screws, nails or glue the hall is held together by these pegs.

Close up of crown post
